| Inspection Date | Sun, 27 Sep 2026 |
| Property / Site Name | Example Commercial Property |
| Address | 66-70 Waples Road Unanderra |
| Project / Reference No. | BP-SAMPLE-001 |

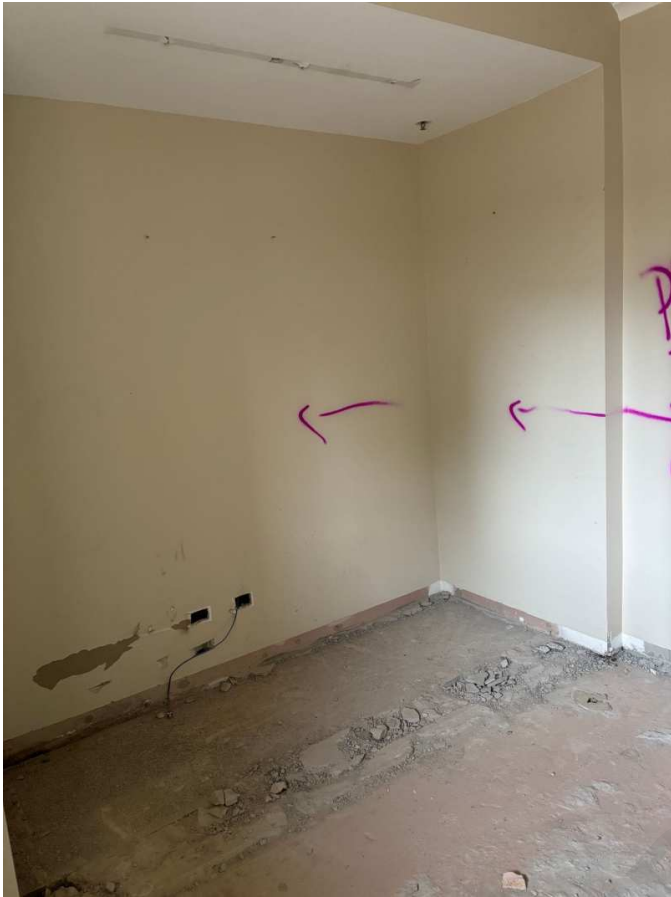
Photo 1

| Item | Area / Location | Defect Description | Photo |
|---|---|---|---|
| 1 | Marco Polo Internal | Internal areas generally presented in fair to good condition. Localised wall and ceiling surface marks, minor cracking and general wear consistent with the age and use of the building were observed. Existing finishes and visible conditions are recorded in the accompanying photographs. | <br><br>1 2 3 4 5<br>6<br>See full page photos attached at end of PDF |

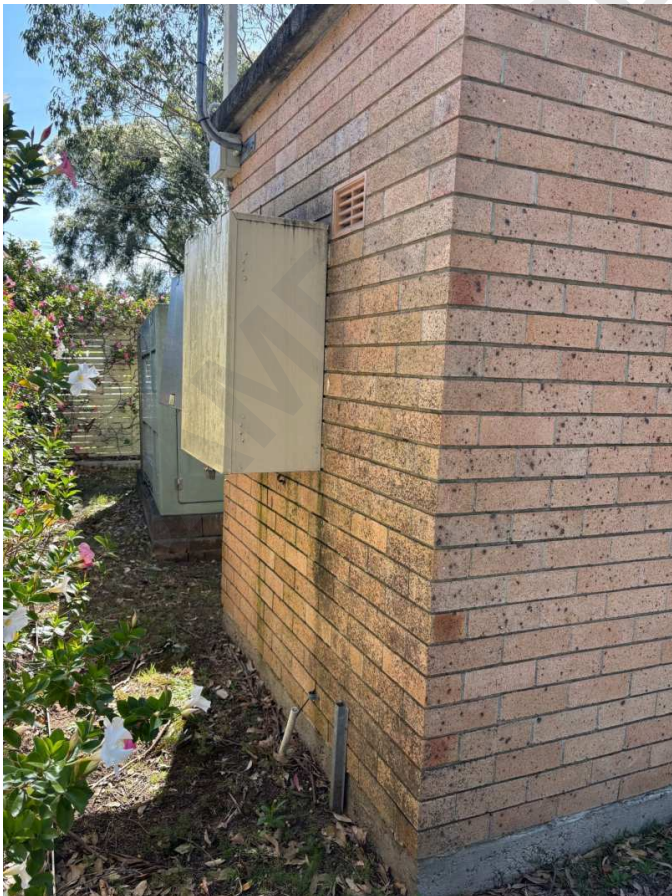
Photo 7

| Item | Area / Location | Defect Description | Photo |
|---|---|---|---|
| 2 | Marco Polo External | External building elements generally presented in fair condition. Minor weathering, surface deterioration and localised cracking were observed to masonry and external finishes. Refer to photographs for the condition of individual elevations and adjoining surfaces at the time of inspection. | <br>7 8 9 10 11<br>See full page photos attached at end of PDF |

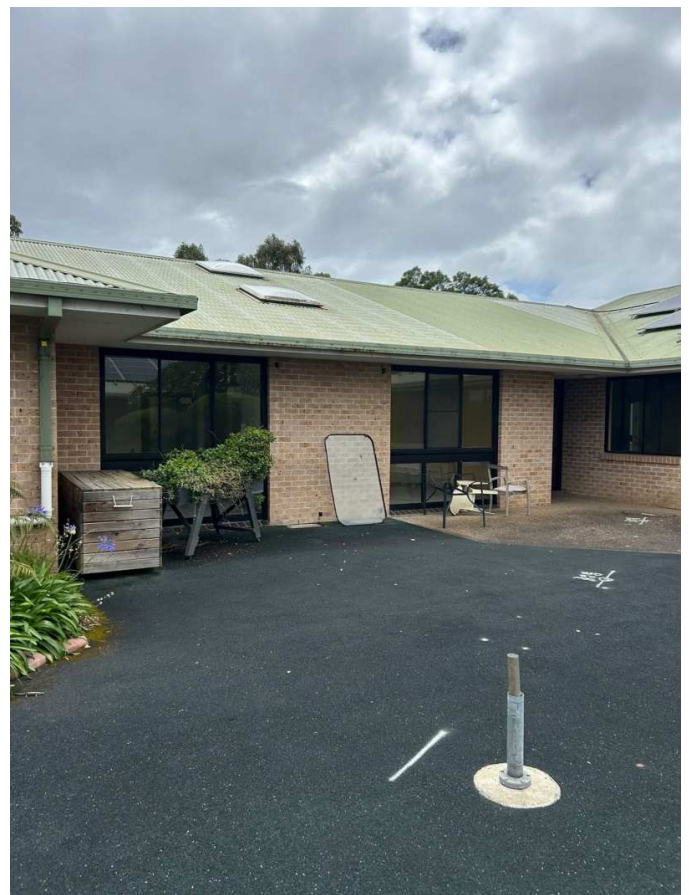
Photo 12

| Item | Area / Location | Defect Description | Photo |
|---|---|---|---|
| 3 | Courtyards | Courtyard areas generally presented in fair condition. Existing weathering and minor deterioration were evident to external surfaces, paving and adjoining building elements. Landscaping and other obstructions restricted visibility to some surfaces. | <br>12 13 14 15<br>See full page photos attached at end of PDF |

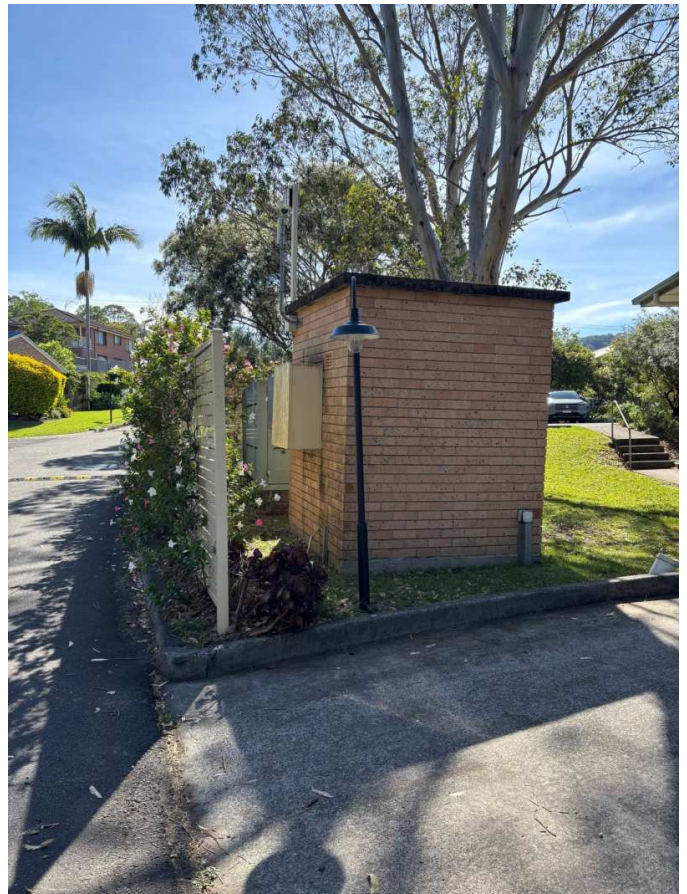
Photo 16

| Item | Area / Location | Defect Description | Photo |
|---|---|---|---|
| 4 | Car Park & Surrounding Areas | Car park and surrounding external areas exhibited general surface wear consistent with regular use. Localised deterioration, staining and minor defects were observed to paved surfaces, kerbs, landscaping interfaces and associated external elements. | <br><br>16 17 18 19 20<br>21<br>See full page photos attached at end of PDF |

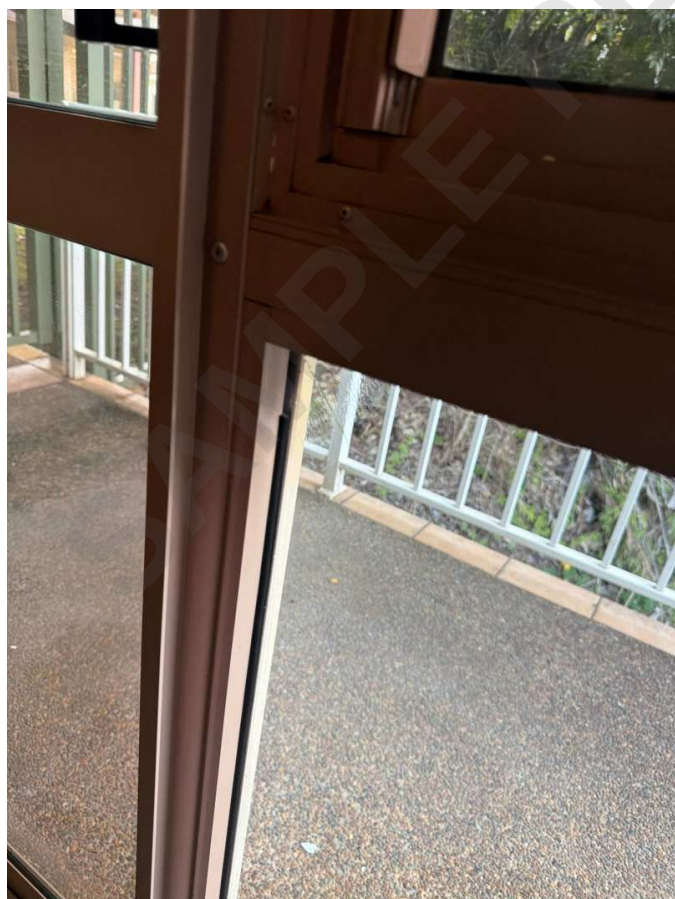
Photo 55

| Item | Area / Location | Defect Description | Photo |
|---|---|---|---|
| 5 | Cordeaux Lodge Internal | Internal areas generally presented in fair to good condition, with localised wear to wall, floor and ceiling finishes. Minor marks, surface deterioration and isolated cracking were observed in some locations. Photographs record the visible condition at the time of inspection. | <br>22 <br>23 <br>24 <br>25 <br>26 <br>27 <br>28 <br>29 <br>30 <br>31 <br>32 <br>33 <br>34 <br>35 <br>36 <br>37 <br>38 <br>39 <br>40 <br>41 <br>42 <br>43 <br>44 <br>45 <br>46 <br>47 <br>48 <br>49 <br>50 <br>51 <br>52 <br>53 <br>54 <br>55 <br>56 <br>57 <br>58 <br>59 <br>60 <br>61 <br>62<br>See full page photos attached at end of PDF |

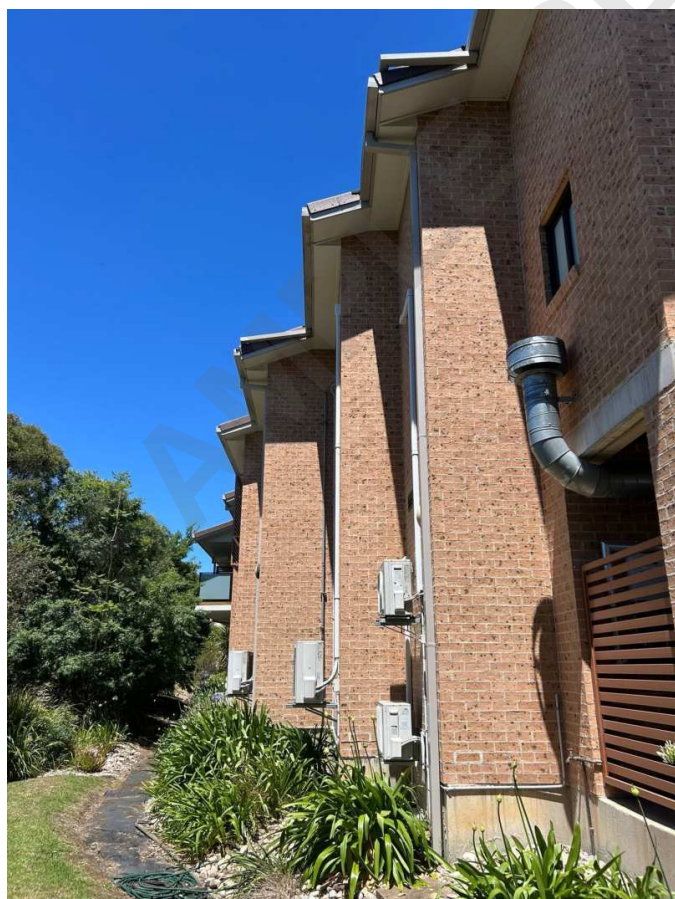
Photo 63

| Item | Area / Location | Defect Description | Photo |
|---|---|---|---|
| 6 | Cordeaux Lodge North Elevation | Masonry, soffits, windows and associated external finishes exhibited normal weathering with isolated areas of minor surface deterioration and cracking visible at the time of inspection. | <br>63 <br>64 <br>65 <br>66 <br>67 <br>68 <br>69 <br>70 <br>71 <br>72<br>See full page photos attached at end of PDF |

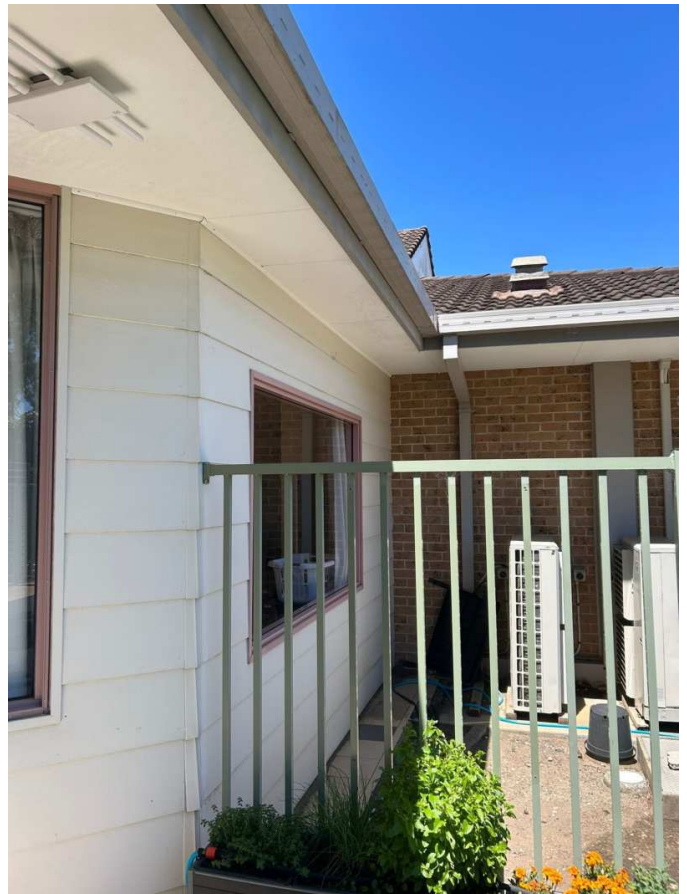
Photo 88

| Item | Area / Location | Defect Description | Photo |
|---|---|---|---|
| 8 | Cordeaux Lodge South Elevation | South elevation generally presented in fair condition. Localised weathering, staining and minor deterioration were observed to external finishes and adjoining building elements. No invasive investigation was undertaken. | 83 84 85 86 87<br> 88 89 90 91 92<br>See full page photos attached at end of PDF |

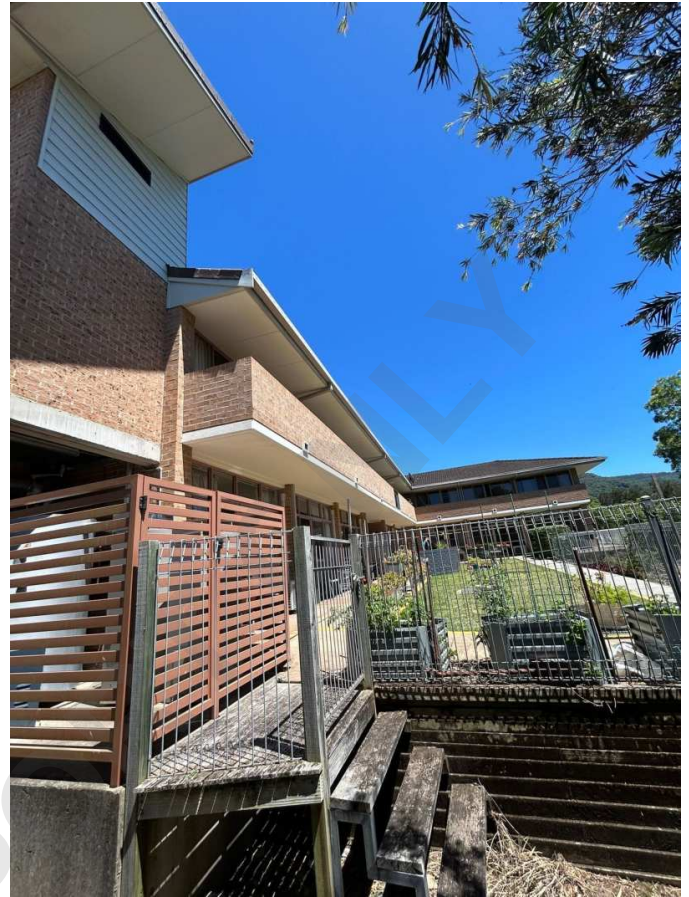
Photo 94

| Item | Area / Location | Defect Description | Photo |
|---|---|---|---|
| 9 | Cordeaux Lodge East Elevation | East elevation exhibited general weathering consistent with the age and exposure of the building. Minor cracking, surface deterioration and localised defects were observed to masonry, soffits and associated external elements as shown in the photographs. | 93 94 95 96 97<br> 98 99 100 101 102<br> 103 104 105 106 107<br>See full page photos attached at end of PDF |

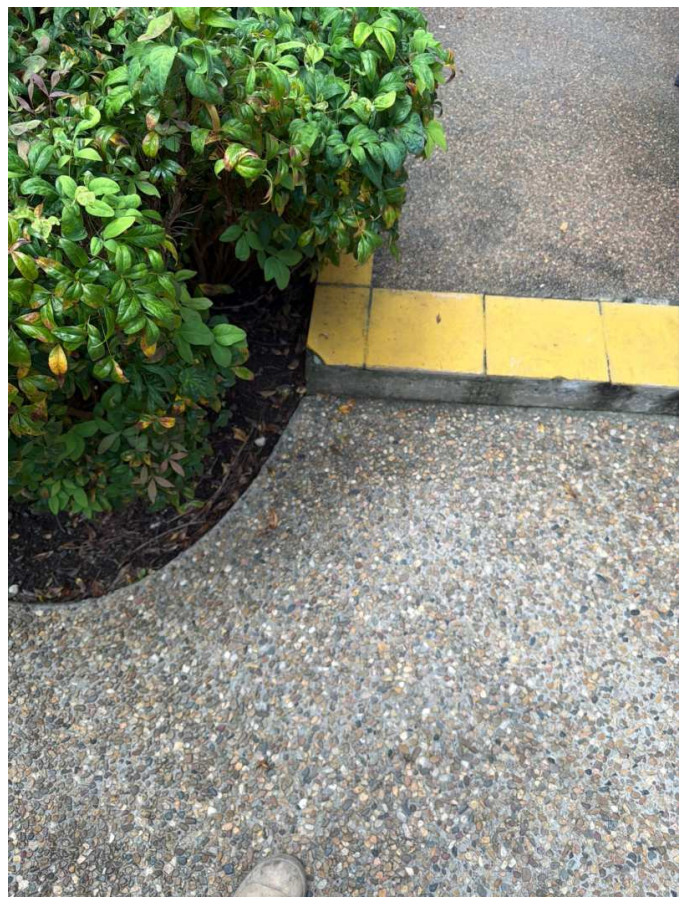
Photo 108

| Item | Area / Location | Defect Description | Photo |
|---|---|---|---|
| 10 | Cordeaux Lodge External & Courtyards | External and courtyard areas generally presented in fair condition. Localised weathering, surface deterioration, staining and minor defects were observed to paved surfaces, balustrades, external finishes and associated building elements. Existing conditions at the time of inspection are documented in the accompanying photographic record. | 40 44 45 108 109<br> 110 111 112 113 114<br> 115 116 117 118 119<br> 120 121<br><p>See full page photos attached at end of PDF</p> |
