| Inspection Date | Sun, 27 Sep 2026 |
| Property / Site Name | Example Commercial Property |
| Address | 66-70 Waples Road Unanderra |
| Project / Reference No. | BP-SAMPLE-001 |

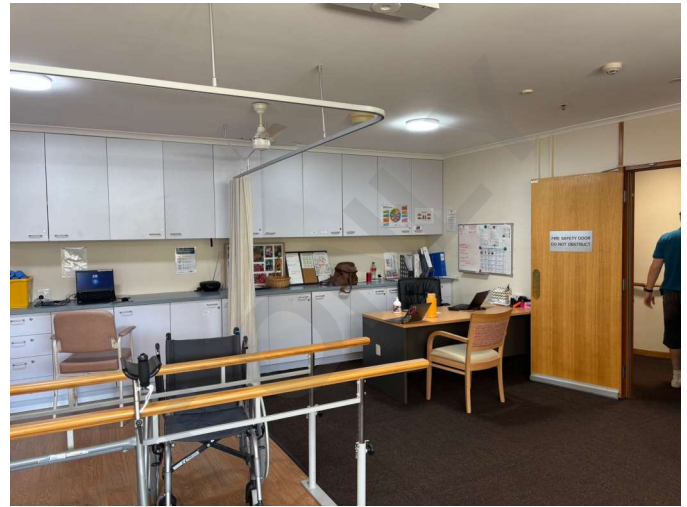
Photo 1

| Item | Area / Location | Defect Description | Photo |
|---|---|---|---|
| 1 | Marco Polo Internal | Internal areas generally presented in fair to good condition. Localised wall and ceiling surface marks, minor cracking and general wear consistent with the age and use of the building were observed. Existing finishes and visible conditions are recorded in the accompanying photographs. | <br><br>1 2 3 4 5<br>6<br>See full page photos attached at end of PDF |

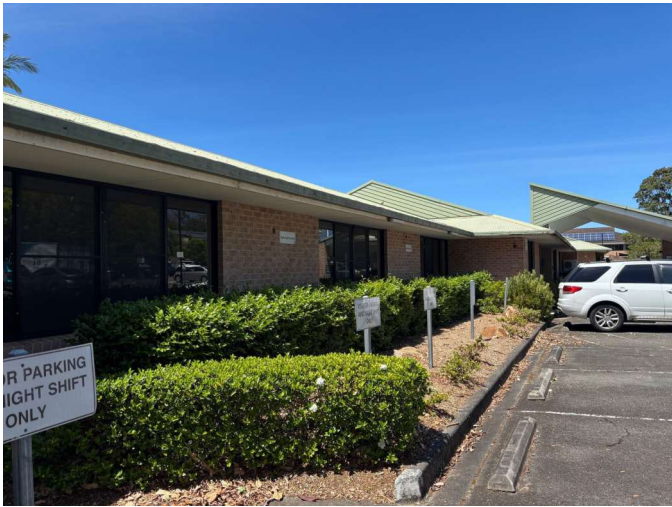
Photo 8

| Item | Area / Location | Defect Description | Photo |
|---|---|---|---|
| 2 | Marco Polo External | External building elements generally presented in fair condition. Minor weathering, surface deterioration and localised cracking were observed to masonry and external finishes. Refer to photographs for the condition of individual elevations and adjoining surfaces at the time of inspection. | <br>7 8 9 10 11<br>See full page photos attached at end of PDF |

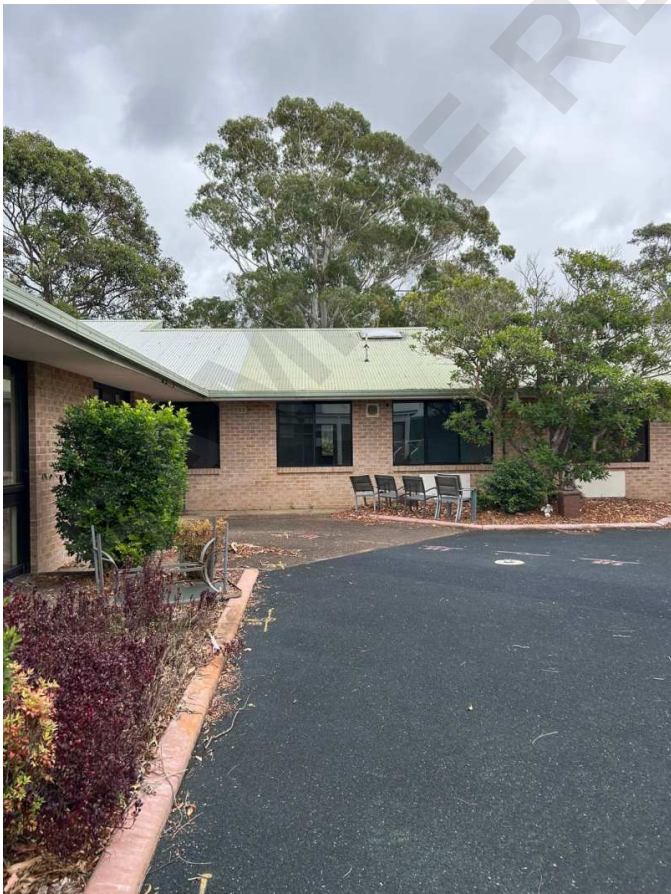
Photo 14

| Item | Area / Location | Defect Description | Photo |
|---|---|---|---|
| 3 | Courtyards | Courtyard areas generally presented in fair condition. Existing weathering and minor deterioration were evident to external surfaces, paving and adjoining building elements. Landscaping and other obstructions restricted visibility to some surfaces. | <br>12 13 14 15<br>See full page photos attached at end of PDF |

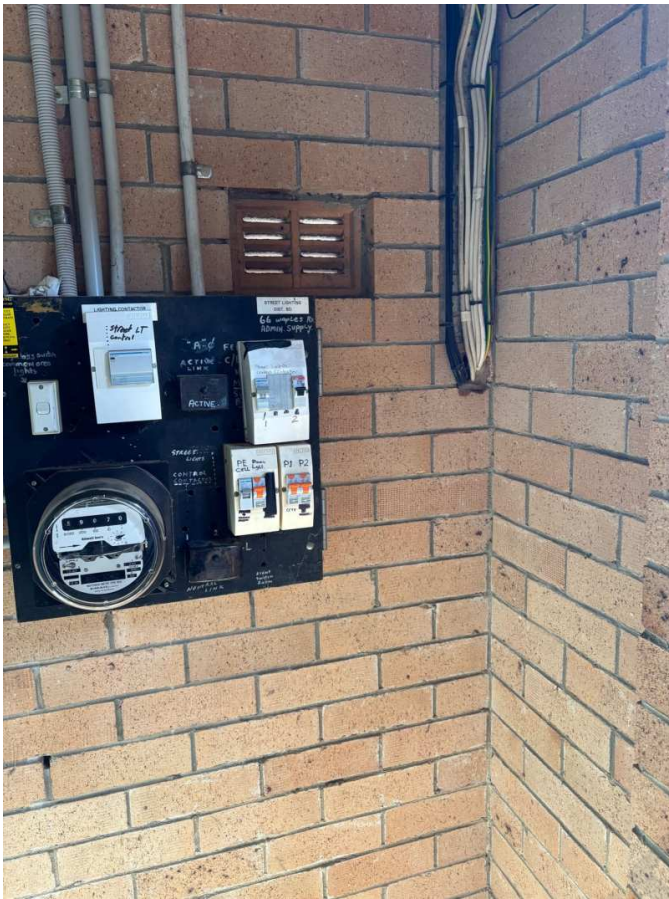
Photo 16

| Item | Area / Location | Defect Description | Photo |
|---|---|---|---|
| 4 | Car Park & Surrounding Areas | Car park and surrounding external areas exhibited general surface wear consistent with regular use. Localised deterioration, staining and minor defects were observed to paved surfaces, kerbs, landscaping interfaces and associated external elements. | <br><br>16 17 18 19 20<br>21<br>See full page photos attached at end of PDF |

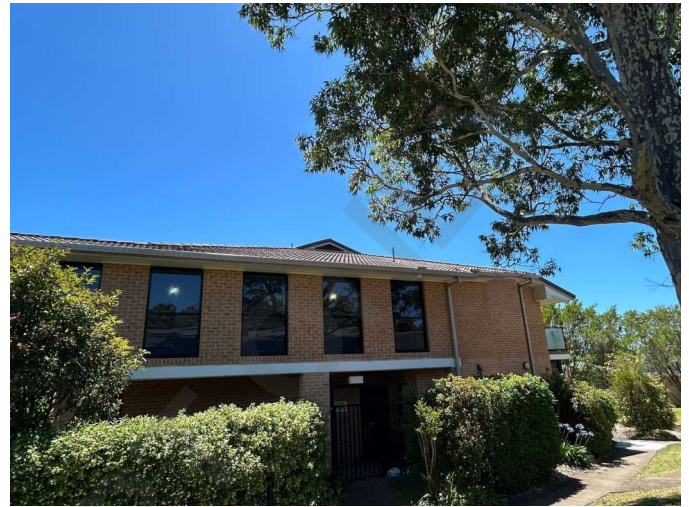
Photo 65

| Item | Area / Location | Defect Description | Photo |
|---|---|---|---|
| 6 | Cordeaux Lodge North Elevation | Masonry, soffits, windows and associated external finishes exhibited normal weathering with isolated areas of minor surface deterioration and cracking visible at the time of inspection. | <br>63 <br>64 <br>65 <br>66 <br>67 <br>68 <br>69 <br>70 <br>71 <br>72<br>See full page photos attached at end of PDF |

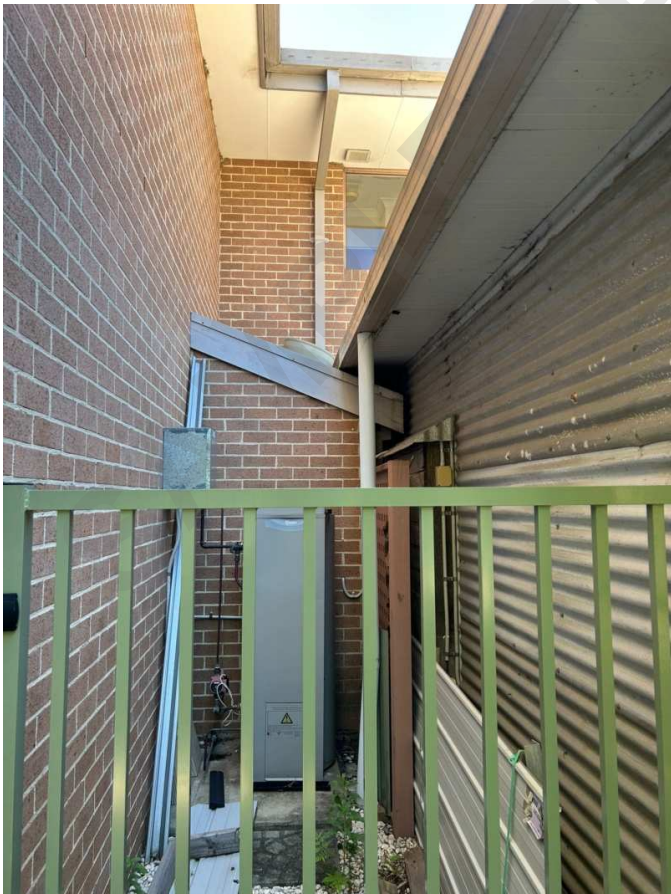
Photo 74

| Item | Area / Location | Defect Description | Photo |
|---|---|---|---|
| 7 | Cordeaux Lodge West Elevation | West elevation exhibited general weathering and ageing to external building finishes. Localised surface marks, minor cracking and deterioration were observed to masonry and associated elements. Existing conditions are documented in the photographic record. | 73 74 75 76 77<br> 78 79 80 81 82<br>See full page photos attached at end of PDF |

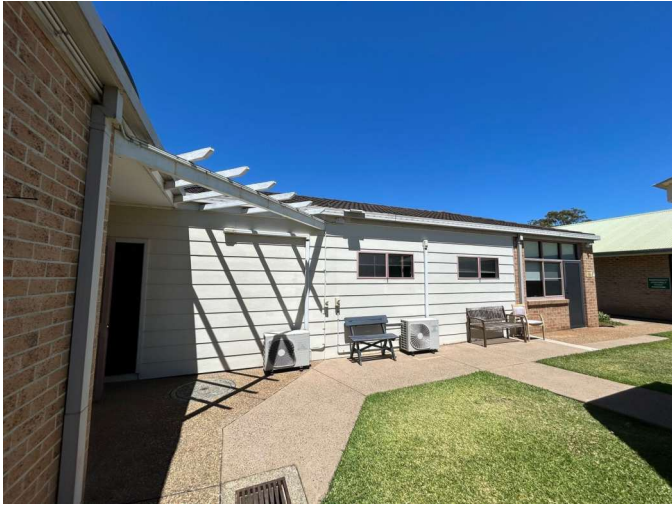
Photo 84

| Item | Area / Location | Defect Description | Photo |
|---|---|---|---|
| 8 | Cordeaux Lodge South Elevation | South elevation generally presented in fair condition. Localised weathering, staining and minor deterioration were observed to external finishes and adjoining building elements. No invasive investigation was undertaken. | 83 84 85 86 87<br> 88 89 90 91 92<br>See full page photos attached at end of PDF |

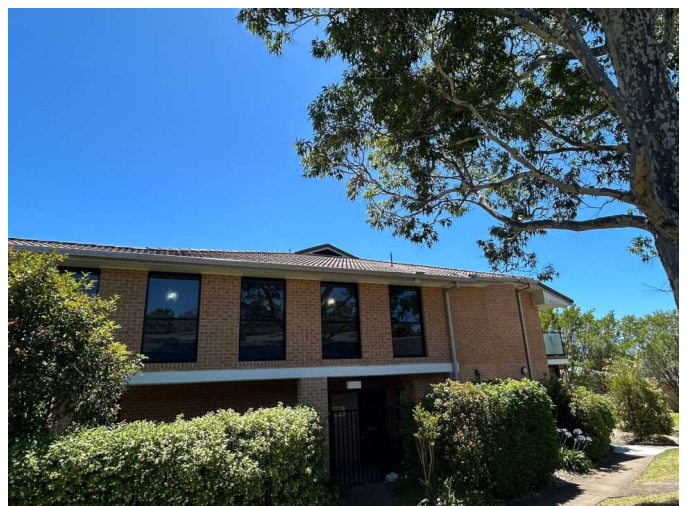
Photo 103

| Item | Area / Location | Defect Description | Photo |
|---|---|---|---|
| 9 | Cordeaux Lodge East Elevation | East elevation exhibited general weathering consistent with the age and exposure of the building. Minor cracking, surface deterioration and localised defects were observed to masonry, soffits and associated external elements as shown in the photographs. | 93 94 95 96 97<br> 98 99 100 101 102<br> 103 104 105 106 107<br>See full page photos attached at end of PDF |

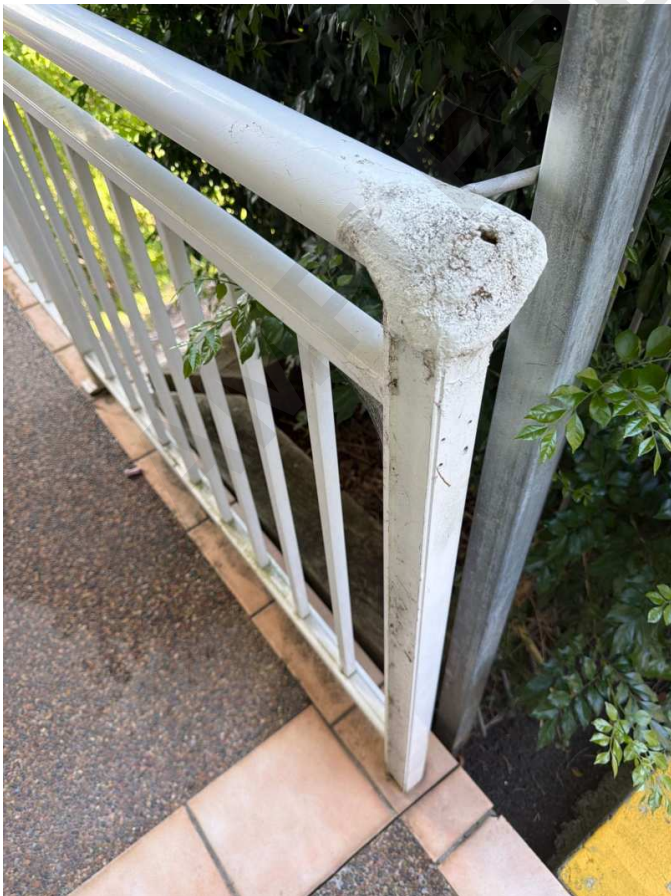
Photo 118

| Item | Area / Location | Defect Description | Photo |
|---|---|---|---|
| 10 | Cordeaux Lodge External & Courtyards | External and courtyard areas generally presented in fair condition. Localised weathering, surface deterioration, staining and minor defects were observed to paved surfaces, balustrades, external finishes and associated building elements. Existing conditions at the time of inspection are documented in the accompanying photographic record. | 40 44 45 108 109<br> 110 111 112 113 114<br> 115 116 117 118 119<br> 120 121<br><p>See full page photos attached at end of PDF</p> |
